**NUMBER:** 24-005-16 REV. A

Blend Door Stuck In Full Heat Mode (X64 Warranty Extension)

2014 - 2015                      (RT)              Chrysler Town & Country  
Dodge Grand Caravan

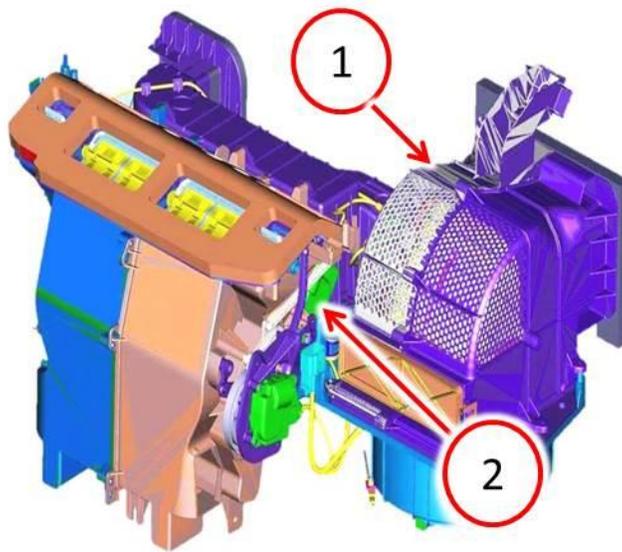
**Fig. 1 Blend Door Actuator - Reference**

This bulletin involves re-calibrating or replacing the right side Heating, Ventilation, Air Conditioning (HVAC) Blend Door actuator.

1 - Right Side HVAC Module

2 - Temperature Blend Door Actuator

6. Remove the right blend door actuator. Refer to the detailed service procedures available in DealerCONNECT> TechCONNECT under: Service Info> 24 - Heating and Air Conditioning/Controls, Front/Actuator, Blend Door/Removal.

7. Install the right blend door actuator. Refer to the detailed service procedures available in DealerCONNECT> TechCONNECT under: Service Info> 24 - Heating and Air Conditioning/Controls, Front/Actuator, Blend Door/Installation.
